Compliance Inspection Report for the Colorado Oil and Gas Conservation Commission

Drilling Operations on Encana's PC22 Site

In Accordance with Rulison Sampling and Analysis Plan, Rev 3

June 27, 2013

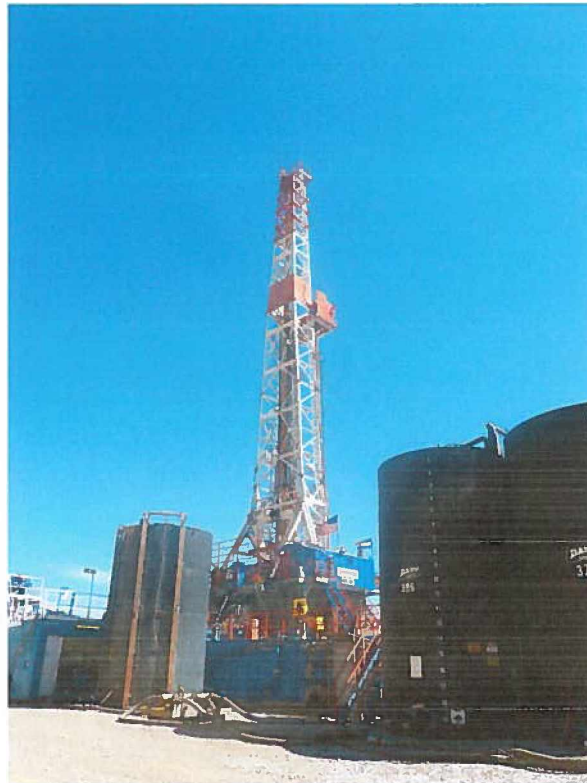
Figure 4. View of drilling Rig 303 on PC22.

The site was under careful control with access rosters, safety briefings, and visitor escort required for entry. Drilling operations were in progress during this inspection.
